Manhole Inspection Summary

Manhole # S17C1_022MH

Insp Date: **5/15/08 10:28 AM**

Location Address: **1908 letitia av**

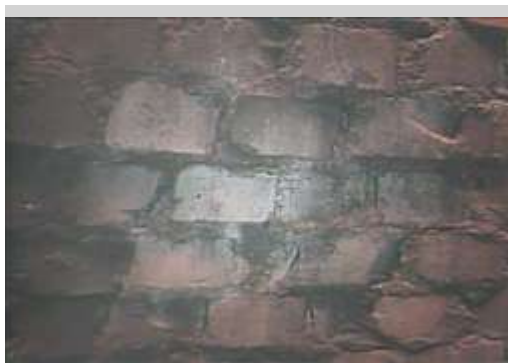
Defect 5

Infiltration: ☐ None ☐ Joint ☐ Cracks ☐ Mortar ☐ Roots ☒ **Wall**

infiltration @ barrel wall

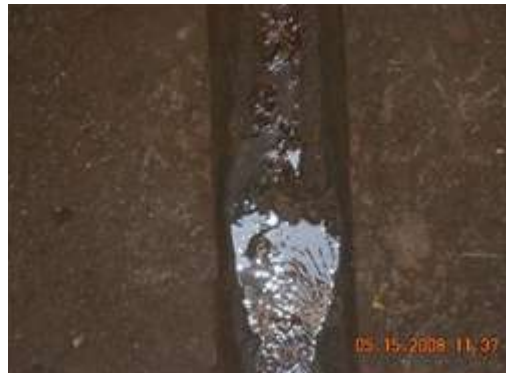
Defect 4

Condition: ☐ Sound ☐ Cracked ☐ Root Intrusion ☐ Deteriorated ☐ Leaks ☒ **Debris**

debris in channel and on bench

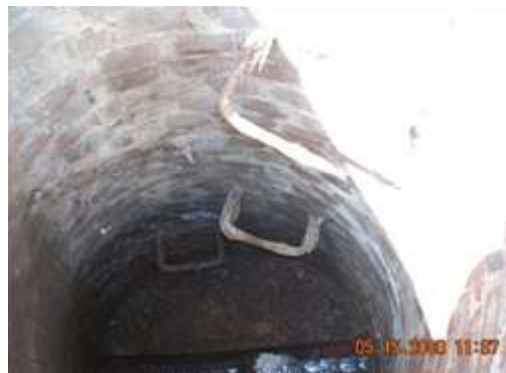
Defect 2

Steps Count: **2** Missing: **2** ☒ **Corroded**

corroded & missing steps

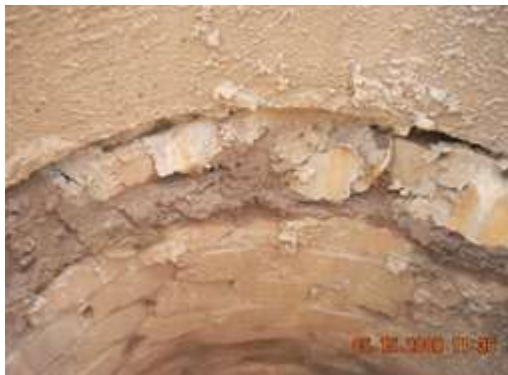
Defect 1

Infiltration: ☐ None ☒ **Joint** ☐ Cracks ☐ Mortar ☐ Roots ☐ Wall

infiltration @ chimney/frame joint

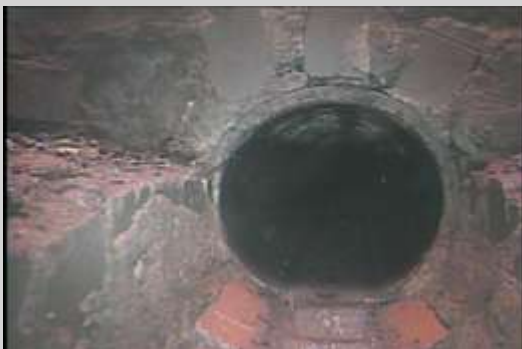
6 O'Clock Inflow

Pipe Height: **8.4** (in.) Rod and Bar (Angled)
Pipe Material: **Clay** ☐ Pipe Lined
Invert Depth: **8.24** (ft.) Flow Characteristics: **Slow**
Deposits: ☒ None ☐ Mud ☐ Sludge ☐ Debris ☐ Grease
Silt Depth: **0** (in.) Deposits Extent:
Infiltration: **None** Pipe Seal Cond: **Cracked**
